# **Upper Little Deschutes River**

## **Recreation Report**

Crescent Ranger District Deschutes National Forest 3/21/2018

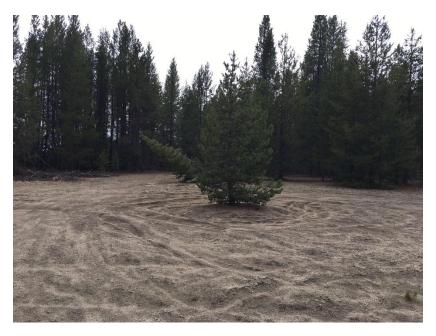
Figure 1: Evidence of motorized use resource damage. 'Donuts' and large ruts in the pumice are evident at Dispersed Site #14.

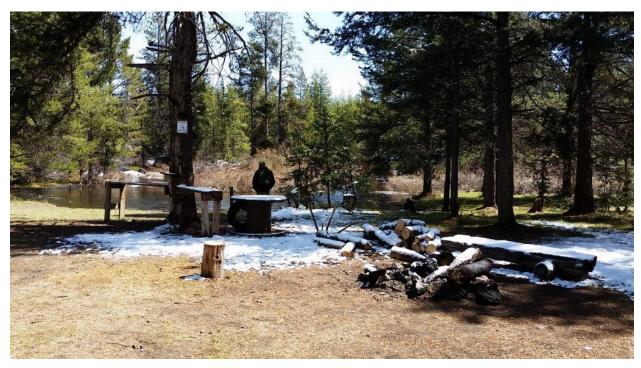
Figure 2: Dispersed site (DS) #12 in southern section of project area.

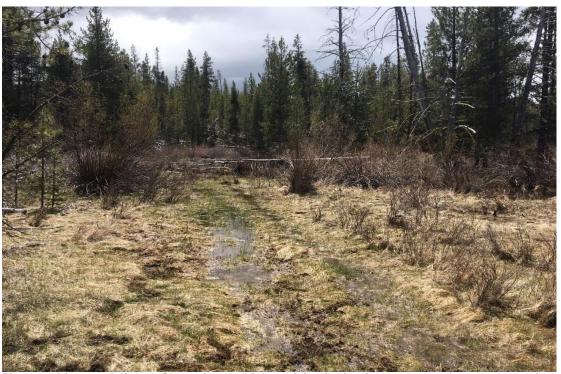
Figure 3: Dispersed site #9. Shows how vehicles driving in riparian areas can damage vegetation and wildlife habitat.

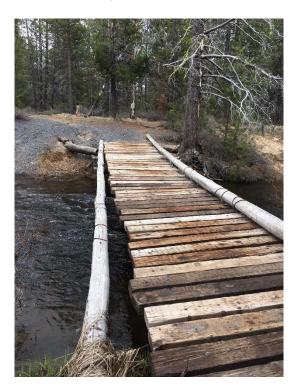
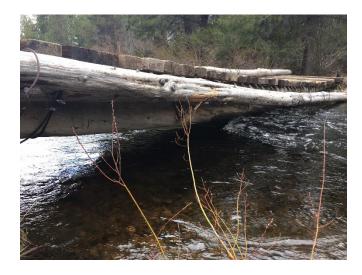
Figure 4a and 4b: Unauthorized bridge at DS #14. Forest Service land is located on both sides of the bridge.

Without a crossing a 'bridge-out', there are no Forest Service bridges. Due to the other roads within the project area, a bridge is not needed for management or firefighting uses. Snowmobile riders at the public meeting expressed interest in creating a new Forest Service crossing. Since there are no designated snowmobile routes within the project area, the crossing would be for dispersed snowmobiling or for local traffic off of private property. The existing unauthorized bridge is not only causing resource damage to the river and riparian area, it is also unsafe. Forest visitors might assume the bridge is maintained by the Forest Service and not realize its limitations or risks. No weight bearing or safety inspections have been documented.

The unauthorized bridge at DS #14 will be removed as part of the proposed action. Removal of the bridge will ensure the safety of travelers in the area. Current users of the bridge (mostly local near-by residents) will have to travel farther to cross the Little Deschutes River to access the same Forest Service land. Although this may be inconvenient for a select number of individuals, it will stop the resource damage

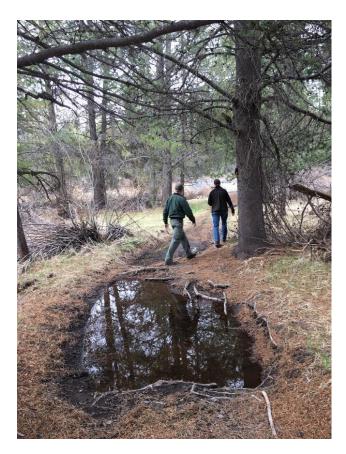
Figure 5: User trail through riparian to access unauthorized bridge at DS #14.

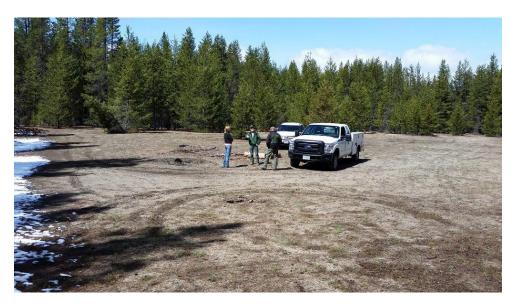
impossible for new vegetation to get established (DS #14 and 17). Illegal or unauthorized use that causes resource damage diminishes the experience for other forest visitors that want to appreciate the natural setting.

Figure 6: Dispersed site #14. Motorized use has completed removed all vegetation within the site.

The only sites that would be closed to motor vehicle access would be DS #8, Dump #1, Dump #2, and DS #14. Although DS #8 and #14 may have previously served as camp sites, they are only operating as dump sites or ATV sand pits. Once cleaned up and restored, visitors will still be able to walk through the site but not drive their vehicle. There is no evidence of camping at Dump #1 or #2. Increasing the Forest Service presence in the area will help curb misuse of dispersed camp sites (dumping, residing). It will also be necessary to ensure the site refining and bouldering remains in place. Within the last two years, the local field ranger has been more frequently visiting the ULDR project area. The District has already seen an improvement in trash, dumping, and resource damage. People illegally residing or camping longer than two weeks are still likely to frequent the area due to the rising homeless population in central Oregon. The proposed action may not be able to prevent them from coming to the ULDR project area however it should minimize potential resource damage and impact to other campers.

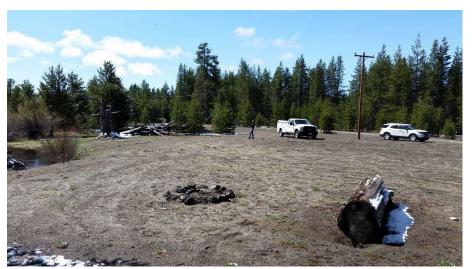
Figure 7: Dispersed site #17. System road is in far right of picture, Little Deschutes is in the far left.

Dispersed camping has a high value for many visitors but unmanaged dispersed campsites, if left unchecked, will continue to expand and remove vegetation adjacent to the river. This expansion contributes to sedimentation, reduced plant and wildlife habitat, and impairs water quality and water storage (Table 1, Figure 7 and 9).

DS #17	Pull boundary of site away from the riparian area, define with brush, bouldering, bollards, and/or signage and rehab riparian area.			
DS #18	Old Campground area. Define site to existing boundary by utilizing brush, bouldering, bollards, and/or signage and rehab riparian area.			
DS #19	Cabin and adjacent site. Utilize buck and pole fencing to be placed by hand to restrict vehicle access to river/meadow. No machinery use in site.

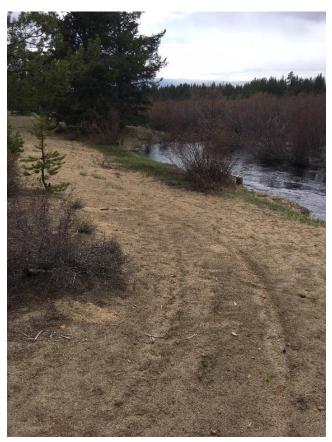
Figure 8: Unrestricted motorized use directly adjacent to the river

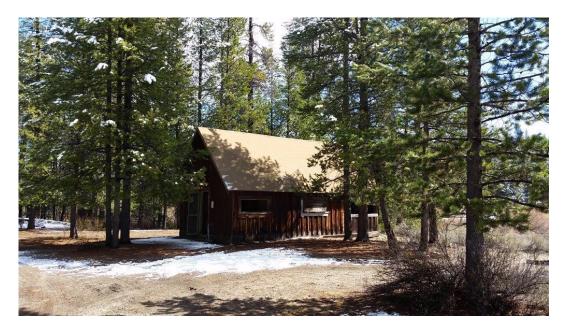
Figure 9: Historic cabin and DS #19

The dispersed camping area around the historic cabin is slowly expanding and diminishing the natural vegetation. Some redefining of the site could protect the natural resources and keep the site at its current size.

- 1. Installation of a single panel interpretive sign near the Little Deschutes Cabin.
  - a. The sign would be installed near the FS 6125-880 road for maximum visibility and require the excavation of two post-holes.
- 2. Any unevaluated sites will be buffered.
